## ENGINEERING REPORT

July 23, 2026

RE: Bladen's River Culvert, Bethmour Road, Bethany, CT

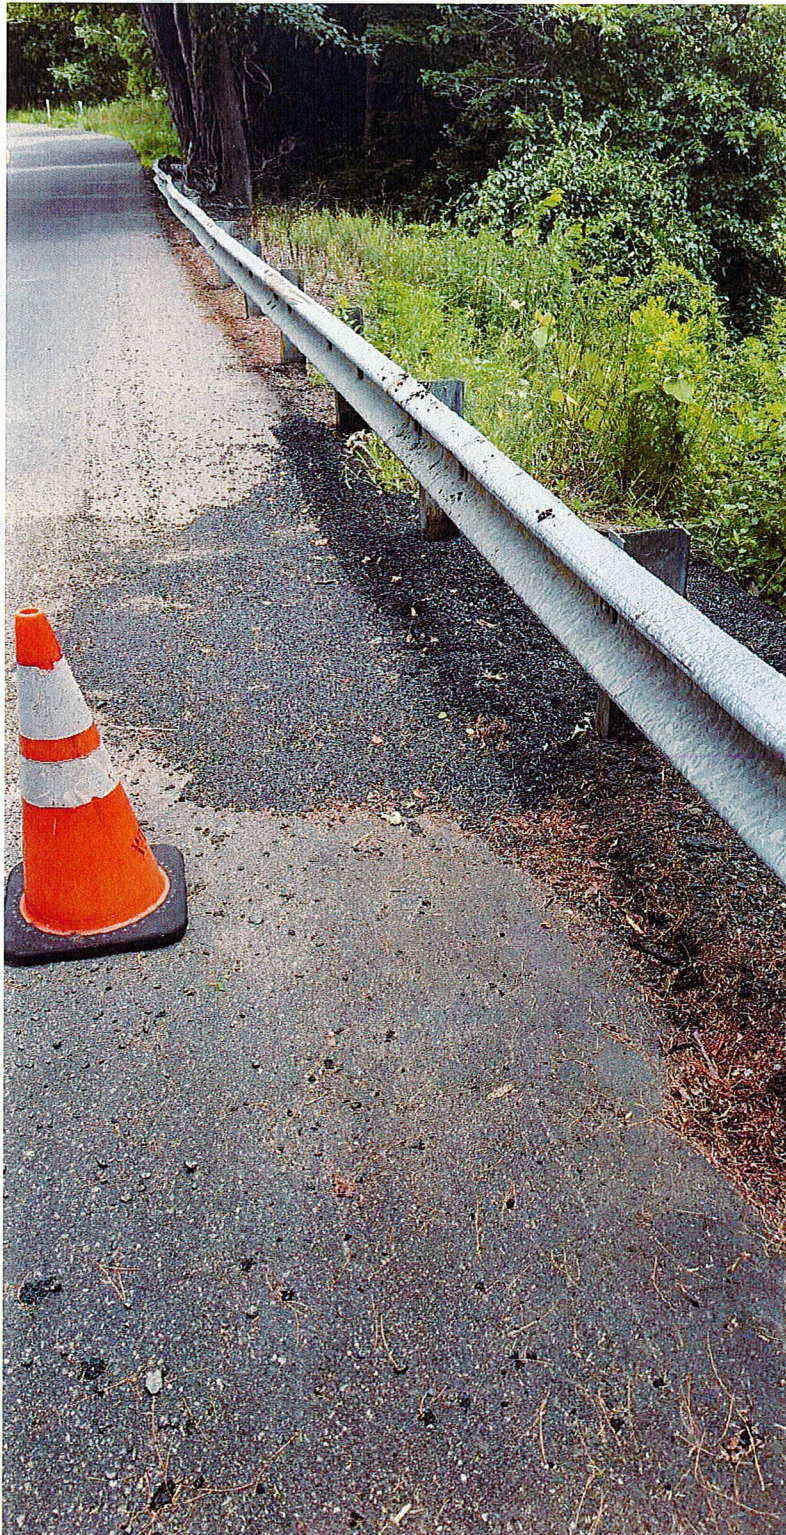
Bethmour Road was closed to traffic, after the July 3, 2026 storm, by the Town of Bethany Public Works Director upon discovery of a large sinkhole adjacent to the culvert. (see Figure 1). Our inspection revealed a large failure in the culvert wall in the Northbound side of the culvert directly below the sinkhole. (see Figure 2). As a result, we notified the Town and the road was closed to vehicular traffic. As requested, we went back out today to see if there was any potential to open even a small portion of the road to traffic. Unfortunately, when we entered the culvert, we observed a second failure in the Southbound side of the culvert. (see figure 3).

*Figure 1 Patched sinkhole on East side of road. Photo taken facing North.*

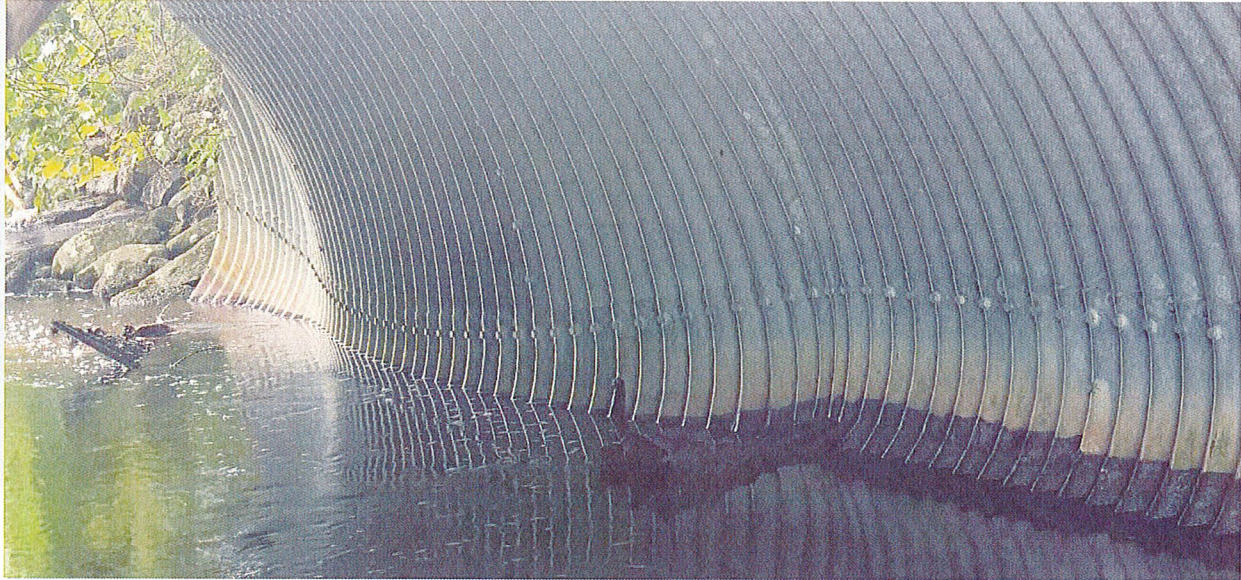
*Figure 2 Bulge in culvert below sinkhole. Photo taken facing East.*

These structural failures indicate that the majority of the culvert has been compromised. Therefore, it is our professional opinion that the road remained closed to all traffic until such time that the culvert can be replaced. Due to the age and damage to the culvert repair is not a viable option. The health and safety of the residents of both towns far outweighs the burden and inconvenience this closure will cause.

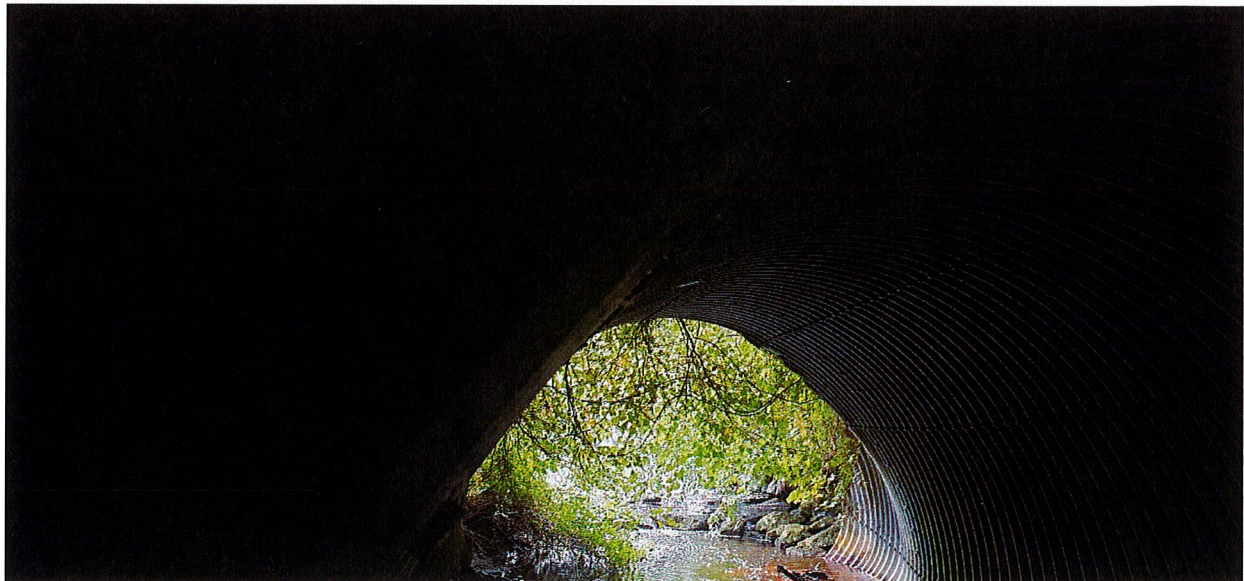
*Figure 3 Flat area of culvert beneath Southbound lane. Photo taken facing East.*
